RE: Site Inspection, Staker Paving and Construction, Beck Street Quarry, M/035/019, Salt Lake County, Utah

Date of Inspection: May 6, 2003  
Time of Inspection: about 9:00 to 11:30 AM  
Conditions: Clear, 50's  
Participants: Stuart Ernst and Mike Dalley, Staker; Doug Jensen and Paul Baker, DOGM

**M/035/019, Beck Street Operation, Staker Paving and Construction**

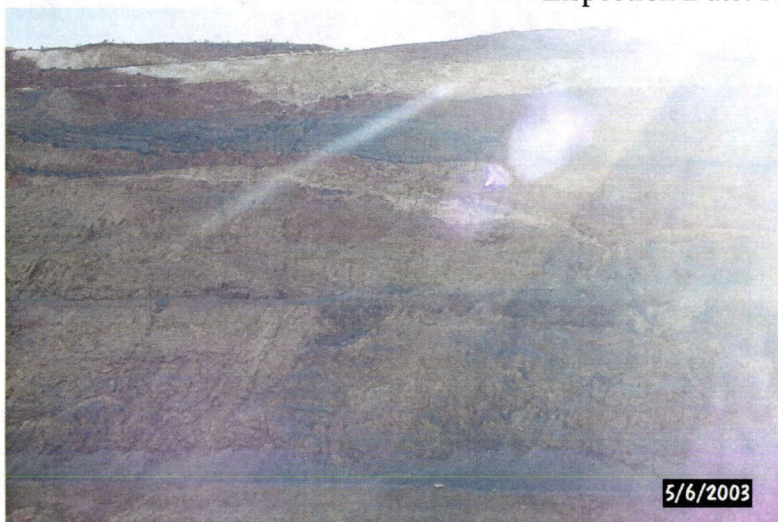
The plan submitted to Salt Lake City discusses an area where mining was complete and where the operator was going to try final reclamation techniques. Although Mr. Ernst and Mr. Dalley did not seem familiar with the commitment to have demonstration benches, they showed us a highwall with benches where mining is probably complete that they believe to be the area discussed in the plan. This highwall is shown in Photo 1.

The plan indicates soil was to be applied on the benches of this highwall and that they were to be seeded, but it does not appear this happened. Some vegetation has become established naturally, but we were not able to examine it closely and I could not tell from a distance what species were there. Some fines appeared to have eroded or wasted on to the benches from the steep parts of the highwall just above the benches, but as far as we could tell, this appeared to have happened soon after the highwall was created, and it was not an ongoing process.

**Photo 1. The highwall where demonstration benches were apparently to have been located.**

It takes a little time for loose material on steep portions of the highwall to erode, and as this material collects on the flatter areas like the benches, it would be detrimental to vegetation that was becoming established. I am not certain how to best handle this problem in consideration of the need to spread soil on the benches soon after they are created and to seed as soon as possible after the soil is distributed.

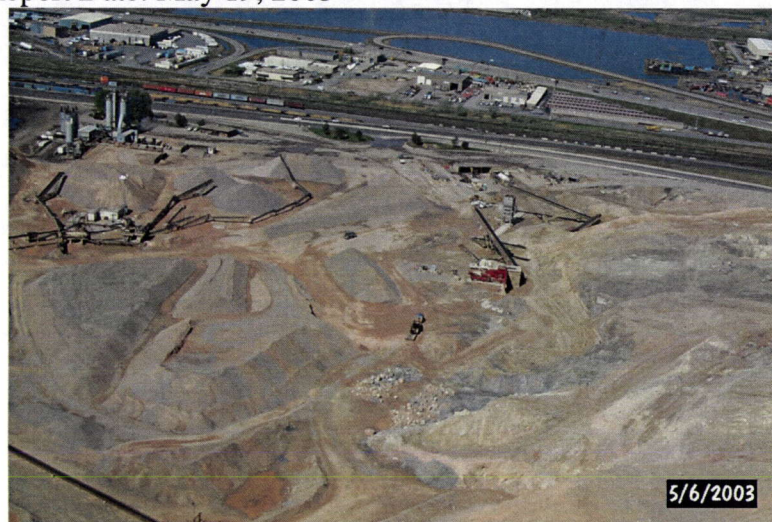
Photos 2 through 4 were taken from the top of the highwall and show portions of the pit area. In the bottom center of Photo 2 and the lower left corner of Photo 4 is the waste material from gravel cleaning operations.

**Photo 3. Another view from the top of the highwall.**

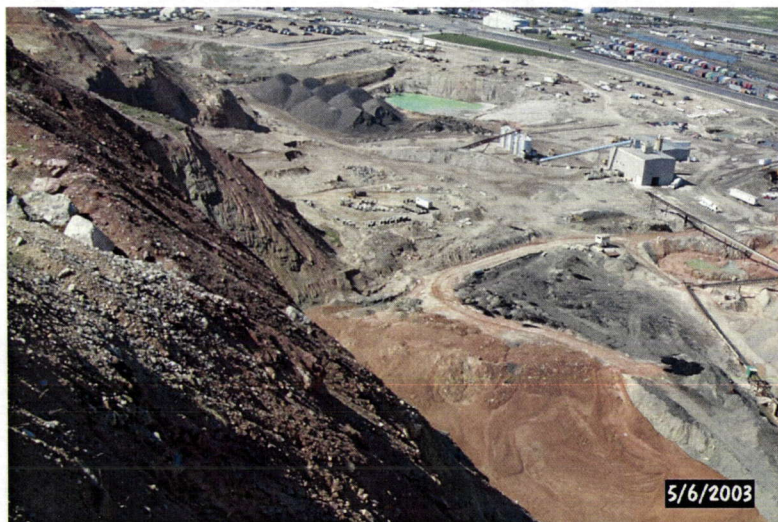
**Photo 2. View from the top of the highwall. Fines from the cleaning process are stored at the base of the highwall (lower center of this photo and lower left corner of Photo 4).**

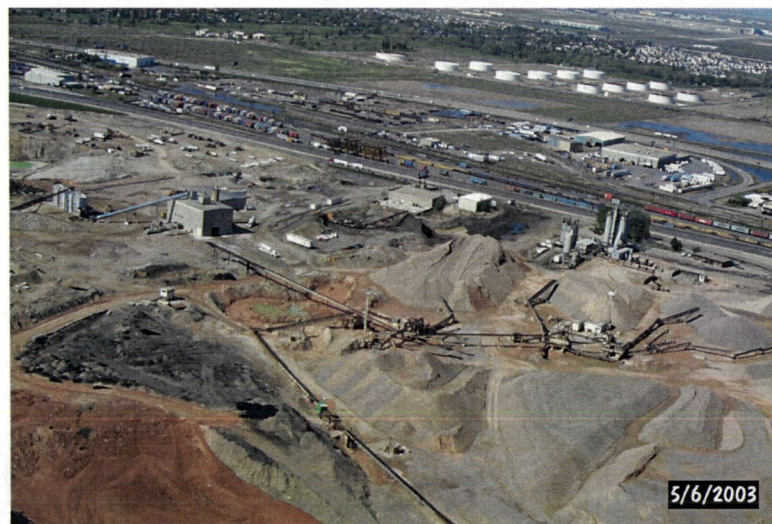
**Photo 4. Another view of the facilities from the top of the highwall.**
